**Colina Bay Subdivision**

**Water Treatment Plant**

**15,000 Gallon  
Hydropneumatic Tank**

Report Date: January 31, 2021

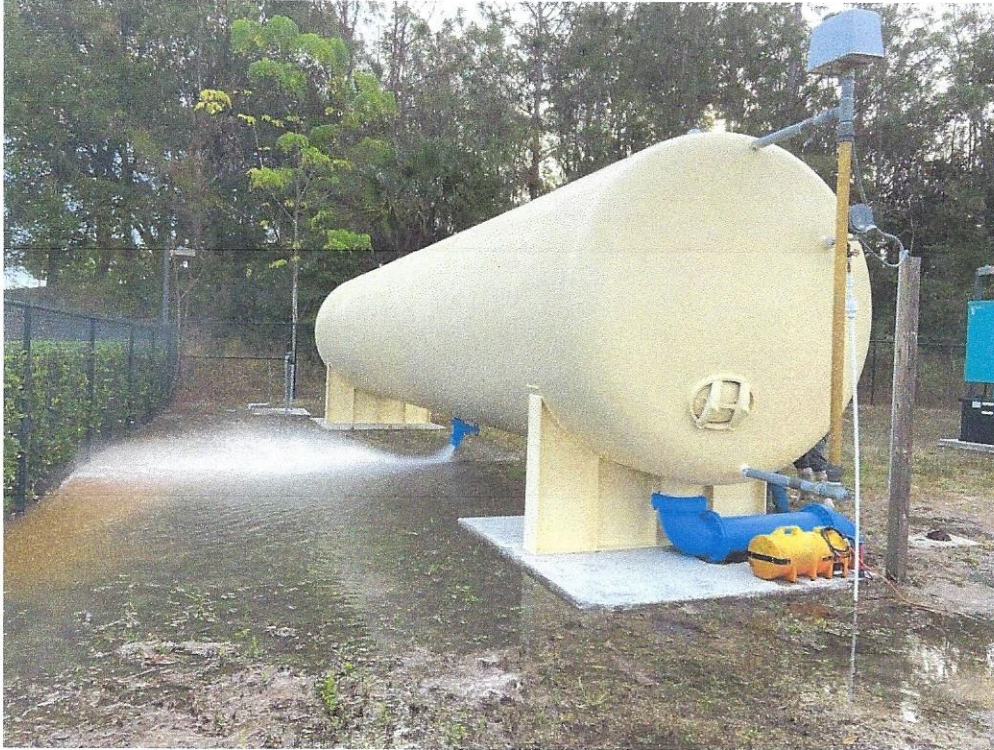
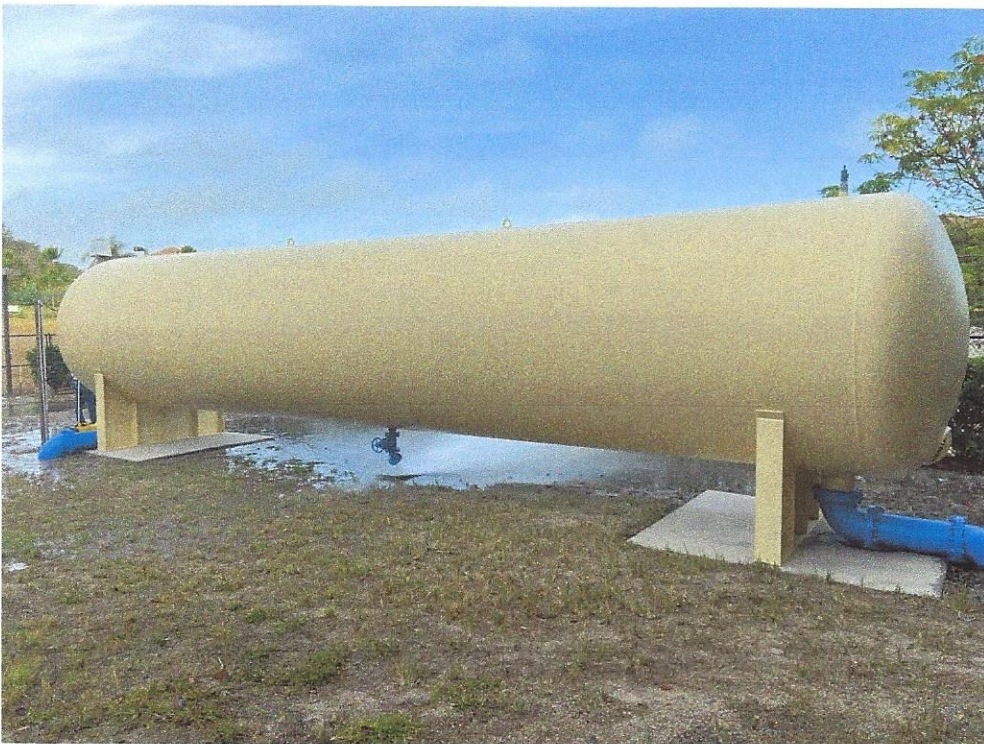
- This hydropneumatic tank does have pressure relief valve.
- The exterior coating of the hydropneumatic tank was in good condition. There were no signs of corrosion. According to Tania Thollebeke, the tank has recently been painted.

Exterior of Tank

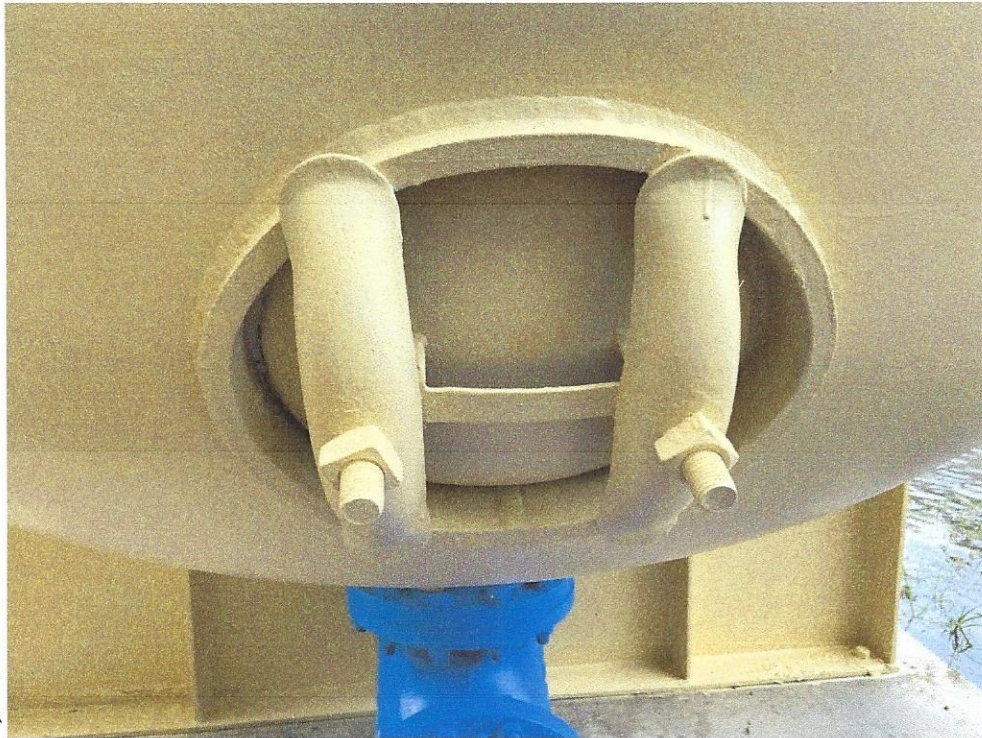
- The shell manhole is oval in shape and held in place against a sidewall extension with a bracket on the tank exterior. The brackets and support bolt (s) holding the covers in place are in good condition.

Access Manhole

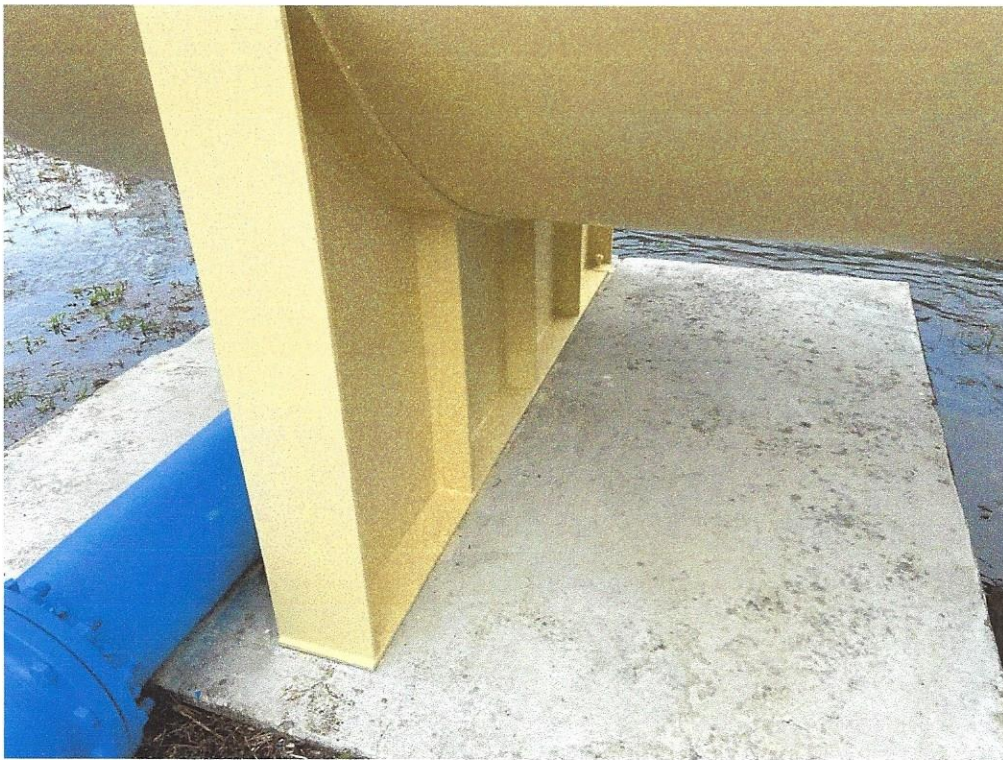
- The steel saddles are in good condition, showing no signs of corrosion.
- The interior coating of the tank was in good/fair condition. There are areas along the inside shell where the protective coating is nonexistent and surface rust is present. However, the structural integrity of the hydropneumatic tank was found to be in good condition.

Steel Saddles

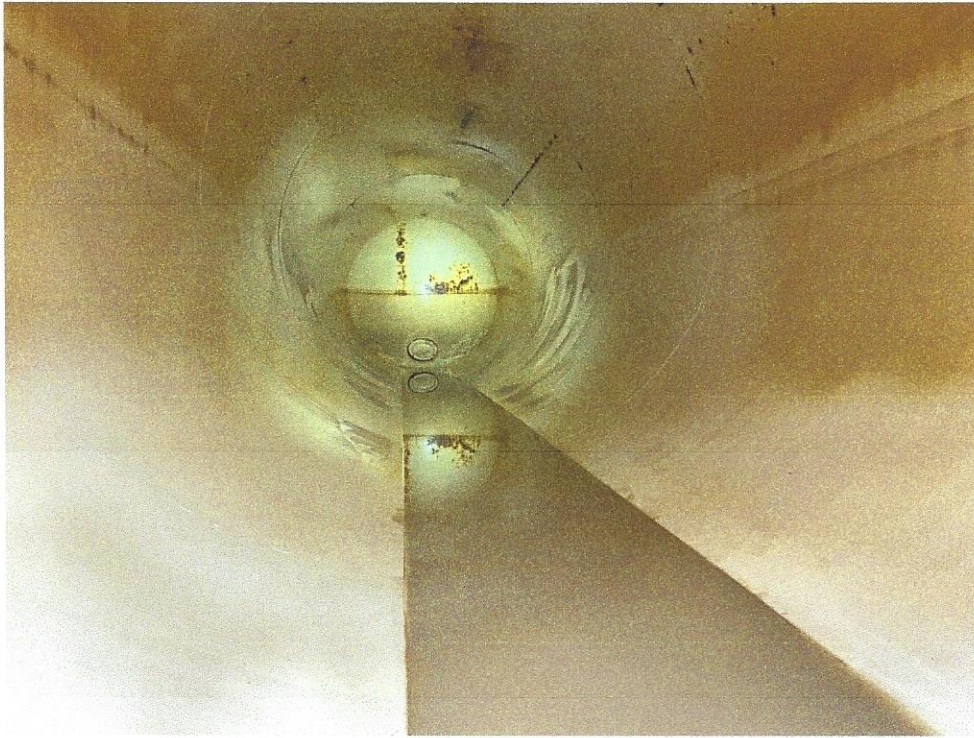
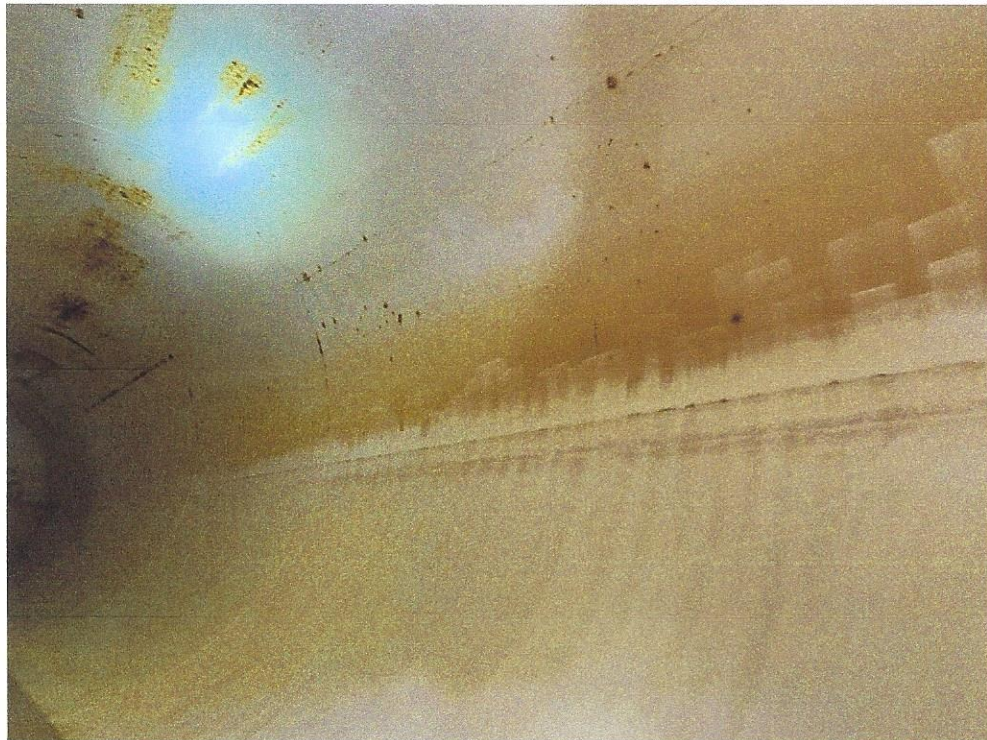
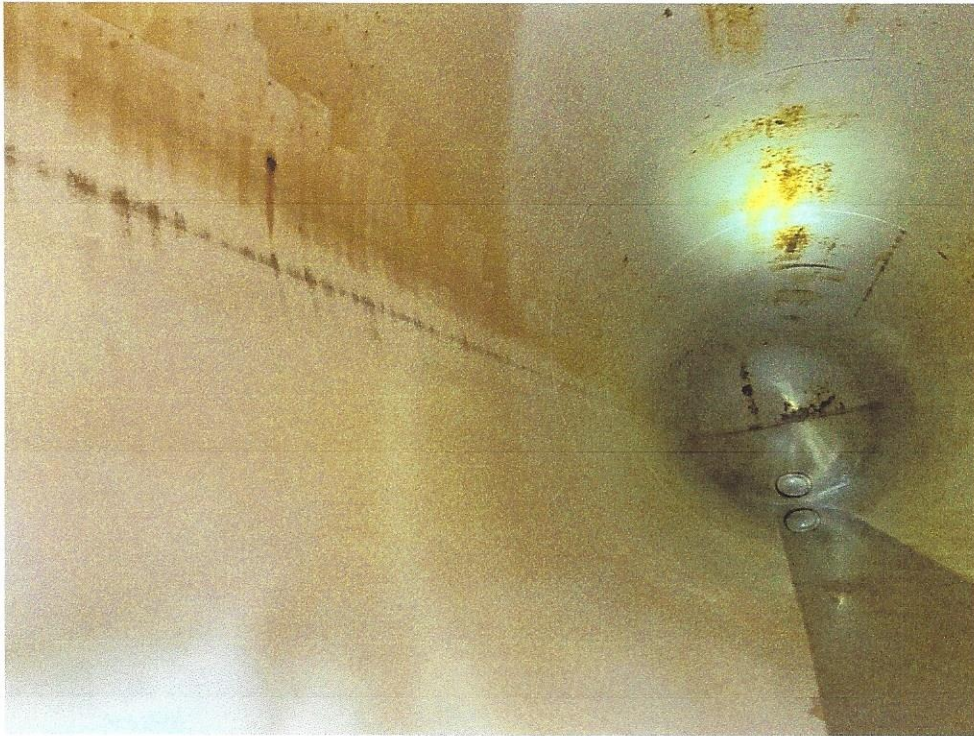
Interior of the tank

Interior of the Tank

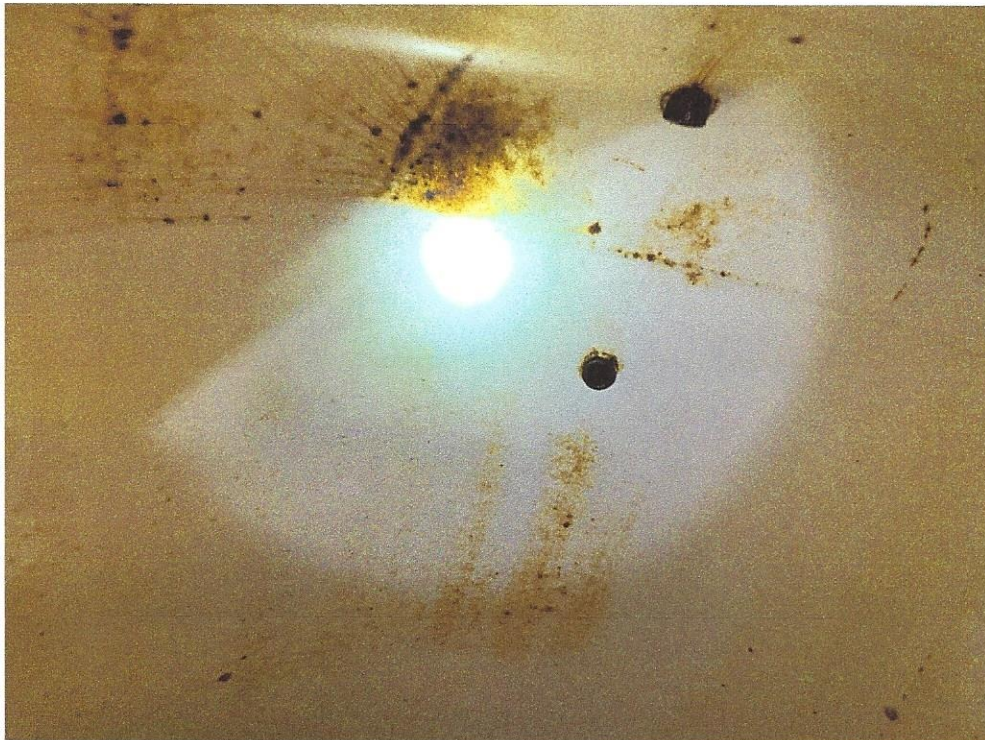
- The interior coating of the hydropneumatic tank was in good/fair condition with some corrosion observed around the fittings and some welds. Although these deficiencies do not affect the structural integrity of the tank nor the quality of the water, the protective coating and the steel will continue to deteriorate under the harsh wet chlorine conditions. To prevent further corrosion and extend the life of the tank, sandblasting and recoating the interior surface of the tank is recommended.

Corrosion spots noted around fittings

- Interior and exterior sand blasting and coating shall be performed by persons experienced in tank renovations and shall be done in accordance with ASME and AWWA standards.
